# Effect of corrosion on the buckling of steel angle elements

### Katalin OSZVALD, PhD student Prof. László DUNAI, supervisor

### Budapest University of Technology and Economics

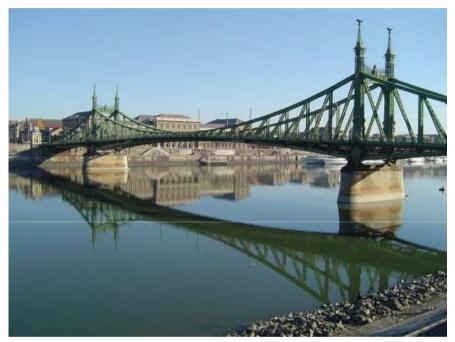
### Liberty Bridge in Budapest

**Construction failure**

**Excavation**

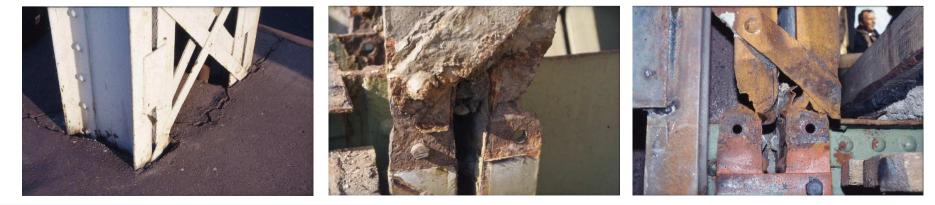
Corrosion → significant reduction of cross-section

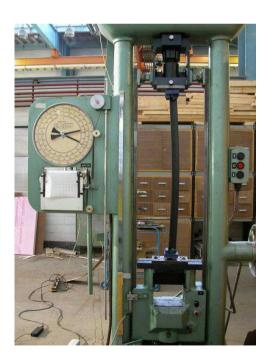
### Test results

Centric compression, measure load, axial and horizontal displacements Failure mode: global buckling in every case
